# TANANA CHIEFS CONFERENCE

Altona Brown Health Clinic • Ruby, Alaska

## FOUNDATION SETTLEMENT ASSESSMENT

November 8, 2016

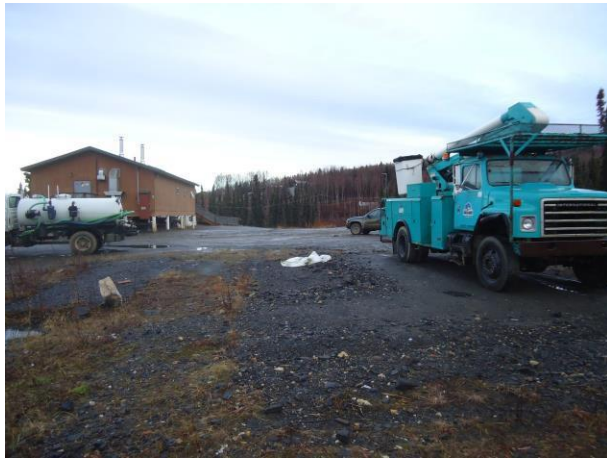
The approximately 30' x 60', 1900 square foot, one-story wood-framed Clinic facility was constructed on a site adjacent to the Washeteria on the same general location where an existing maintenance shop that had since been relocated was sited (see photo #1). During construction, the existing gravel pad was completely covered with new gravel and increased in size to extend beyond the new building footprint (see photo #2).

#1 Building site prior to new clinic construction

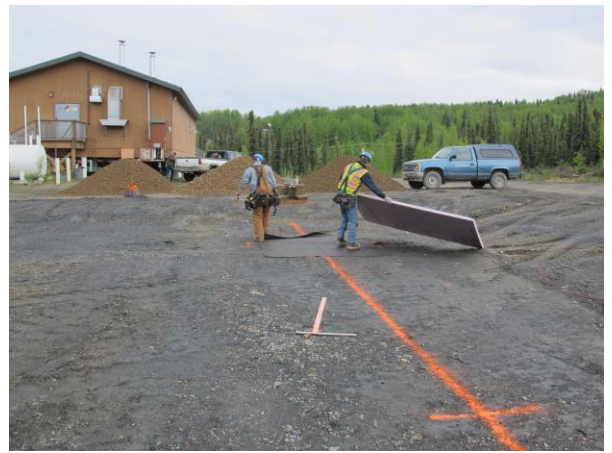
#2 New compacted gravel pad

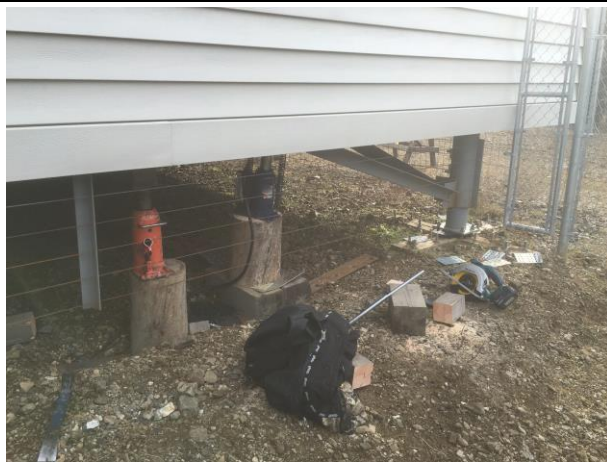
However, it is worth noting that while trying to raise the southwest corner of the building, the jacks and steel support plates sunk approximately 4-6 inches into the ground before meeting enough resistance to raise the building (see photo #3). Any future leveling work should be done when the ground is frozen.

#3 Blocking sunk into gravel 4" to 6" under pressure

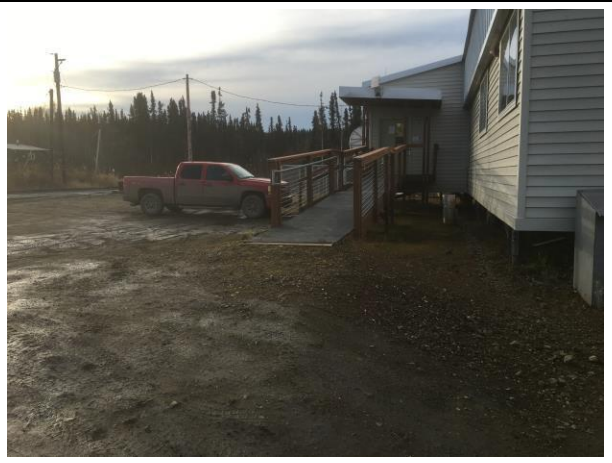
Grading around the building appears comparable to when the building opened in November 2013. While there are some low spots and muddy areas along the west side of the ramp there were no other noticeable indications that the gravel pad had settled unevenly (see photo #4).

#4 Low spots at east side of clinic parking area

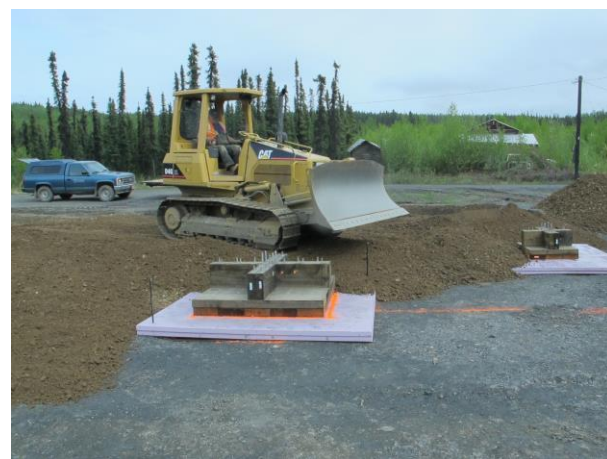
The structural foundation system for the main portion of the building consists of six adjustable steel pipe posts bolted to built-up 4 x 12 treated wood timber footings. Two additional footings and posts support the arctic entry (see Appendix B - foundation plan). All the wood footings sit directly on top of two layers of high density rigid insulation and the footings are buried approximately 18 inches below grade to minimize lateral movement (see photo #5). The wood footing material and steel pipe posts are in very good condition.

#5 Timber footing installation

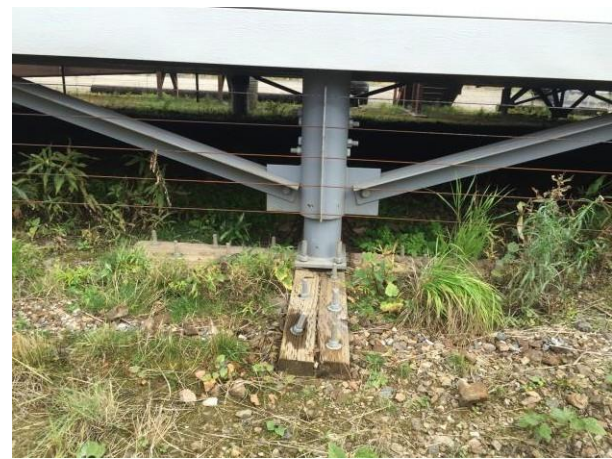
The three footings on the west side of the building have settled the most. The middle footing shows a slight unevenness in the timber footing (see photo #6). The other footings appear to have settled less. This observation is supported by the measurements taken with a laser level. The measurements show the northern most footing of the arctic entry is approximately 2.5 inches higher than the southwest corner of the building (see Appendix B settlement measurements). This would explain why the main entry door drags on the carpet.

#6 Middle footing on west side of clinic

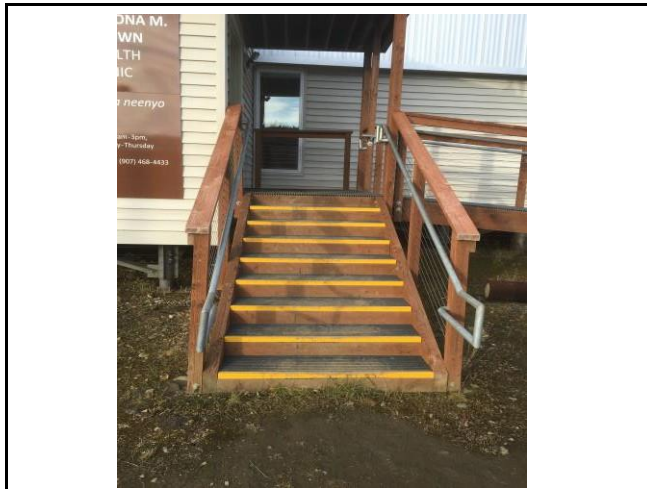
The Clinic building is well maintained and in very good condition. The stairs and ramp on the east side of the building did not show any noticeable signs of settlement (see photo #7). Floor and ceiling finishes did not show any signs of movement. There is a visibly noticeable gap at the intersection of the south wall of the waiting area and ceiling. This was first noted at the time of substantial completion in 2013 and is now approximately 1/8" wide at the worst spot. (see photo #8). Since the gap was there when the building first opened, the cause is likely due to wind uplift and not foundation settlement.

#7 Main entry stairs

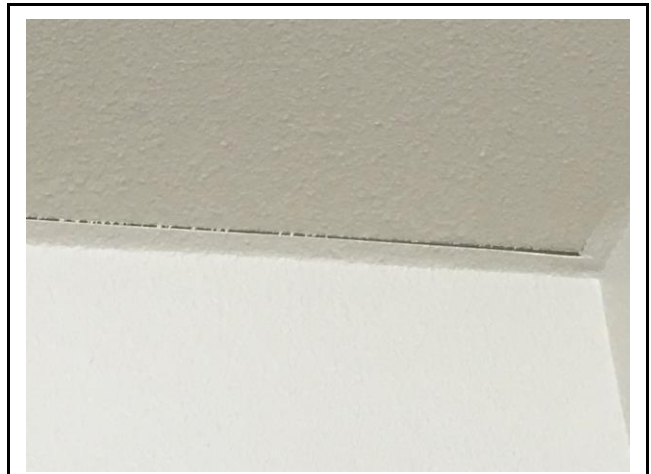
#8 Gap at wall/ceiling intersection in waiting area

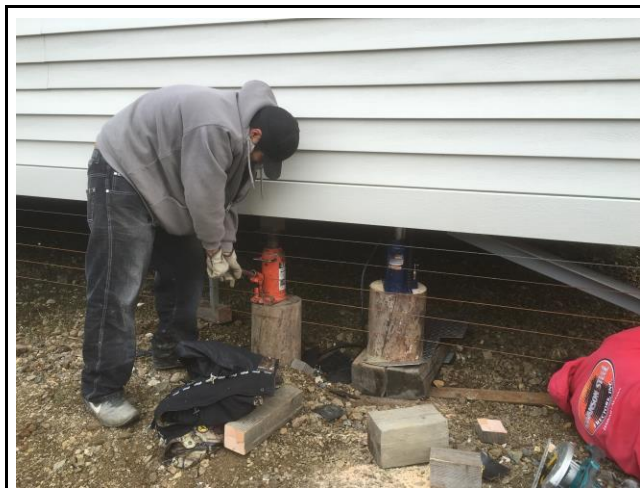
Our initial attempt at raising the building's low point involved setting a 20-ton hydraulic jack on wood timbers approximately five feet from the southwest post. When we started jacking, the wood timbers immediately sank into the soft gravel and we were unable to gain any resistance. Seeing the need to spread the load over a greater surface area, Malcom rounded up steel plate material, a 5-ton jack, more wood timbers and a log. After several attempts using both jacks and various plate and timber arrangements (see photo #9), we were finally able to raise the low point of the building approximately 1.5 inches. High impact bearing shims were placed below the post (see photo #10) but when the pressure from the jacks was released the post lowered approximately 0.5 inches for a final height increase of 1.0 inch (see photo #11). This improvement reduced the height difference between the low point and high point of the building from 2.5 inches to 1.5 inches.

#9 Jacking arrangement

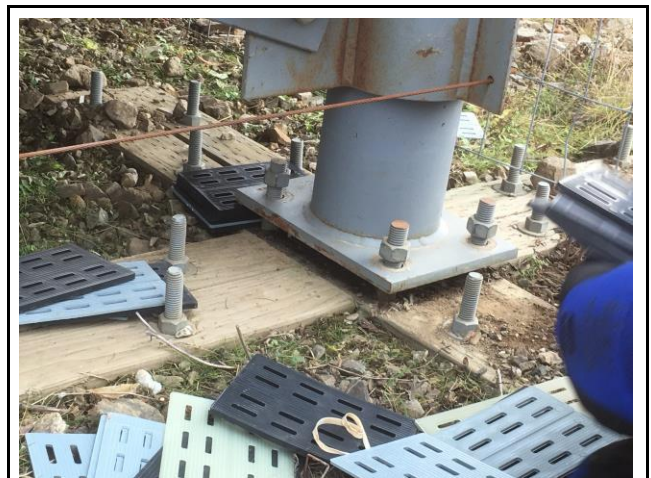
#10 Southwest corner post-raised position

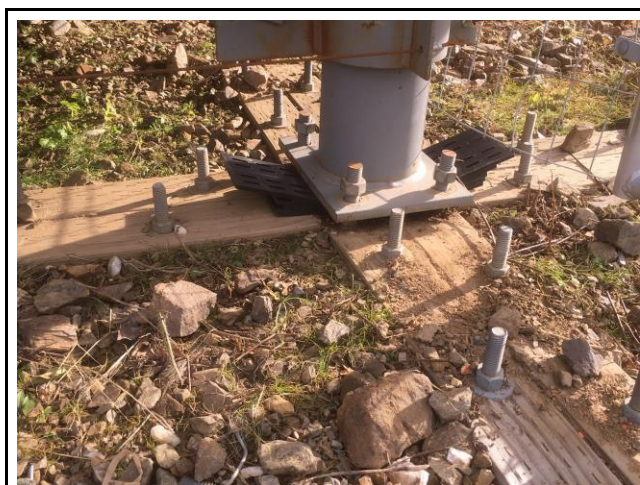
#11 Southwest corner post with shims

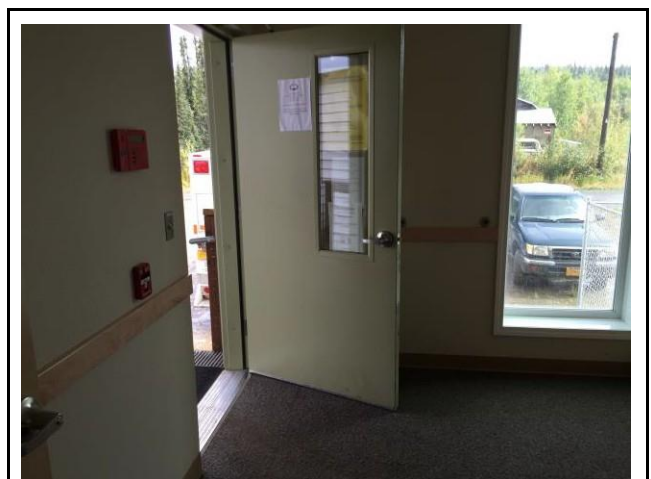
Malcom and Randy investigated the operation of the main entry door and noted the door started to drag on the carpet about one third of the way into the door swing. This condition was likely caused by the foundation post at that location being the high point of the building.

Randy tried to reduce the door drag by replacing the screws in the top hinge with much longer ones (see photo #12). This helped some but the foundation post should be lowered too.

#12 Main entry door – drags on carpet

In the short-term I recommend the one foundation post below the main entry door be lowered  $\pm 1.0$  inch this year to allow the main door to operate properly. Gutters and downspouts should be added to the building eaves in summer 2017 to reduce the quantity of water saturating the gravel pad where the foundation/footing pads are located.
