# Geotechnical Report Fort Yukon Solar

Devise Project No. 25.214  
November 2025

Devise Engineering, Inc. (Devise) is pleased to present this geotechnical data and design recommendations report to support the design and construction of a solar array in Fort Yukon, Alaska. The information provided here is based on Devise's geotechnical exploration completed in July 2025.

The proposed facilities for this project include the construction of a solar array and associated site development. This report summarizes the geotechnical field data, soil laboratory testing, and recommendations for the site development and foundations for the solar array.

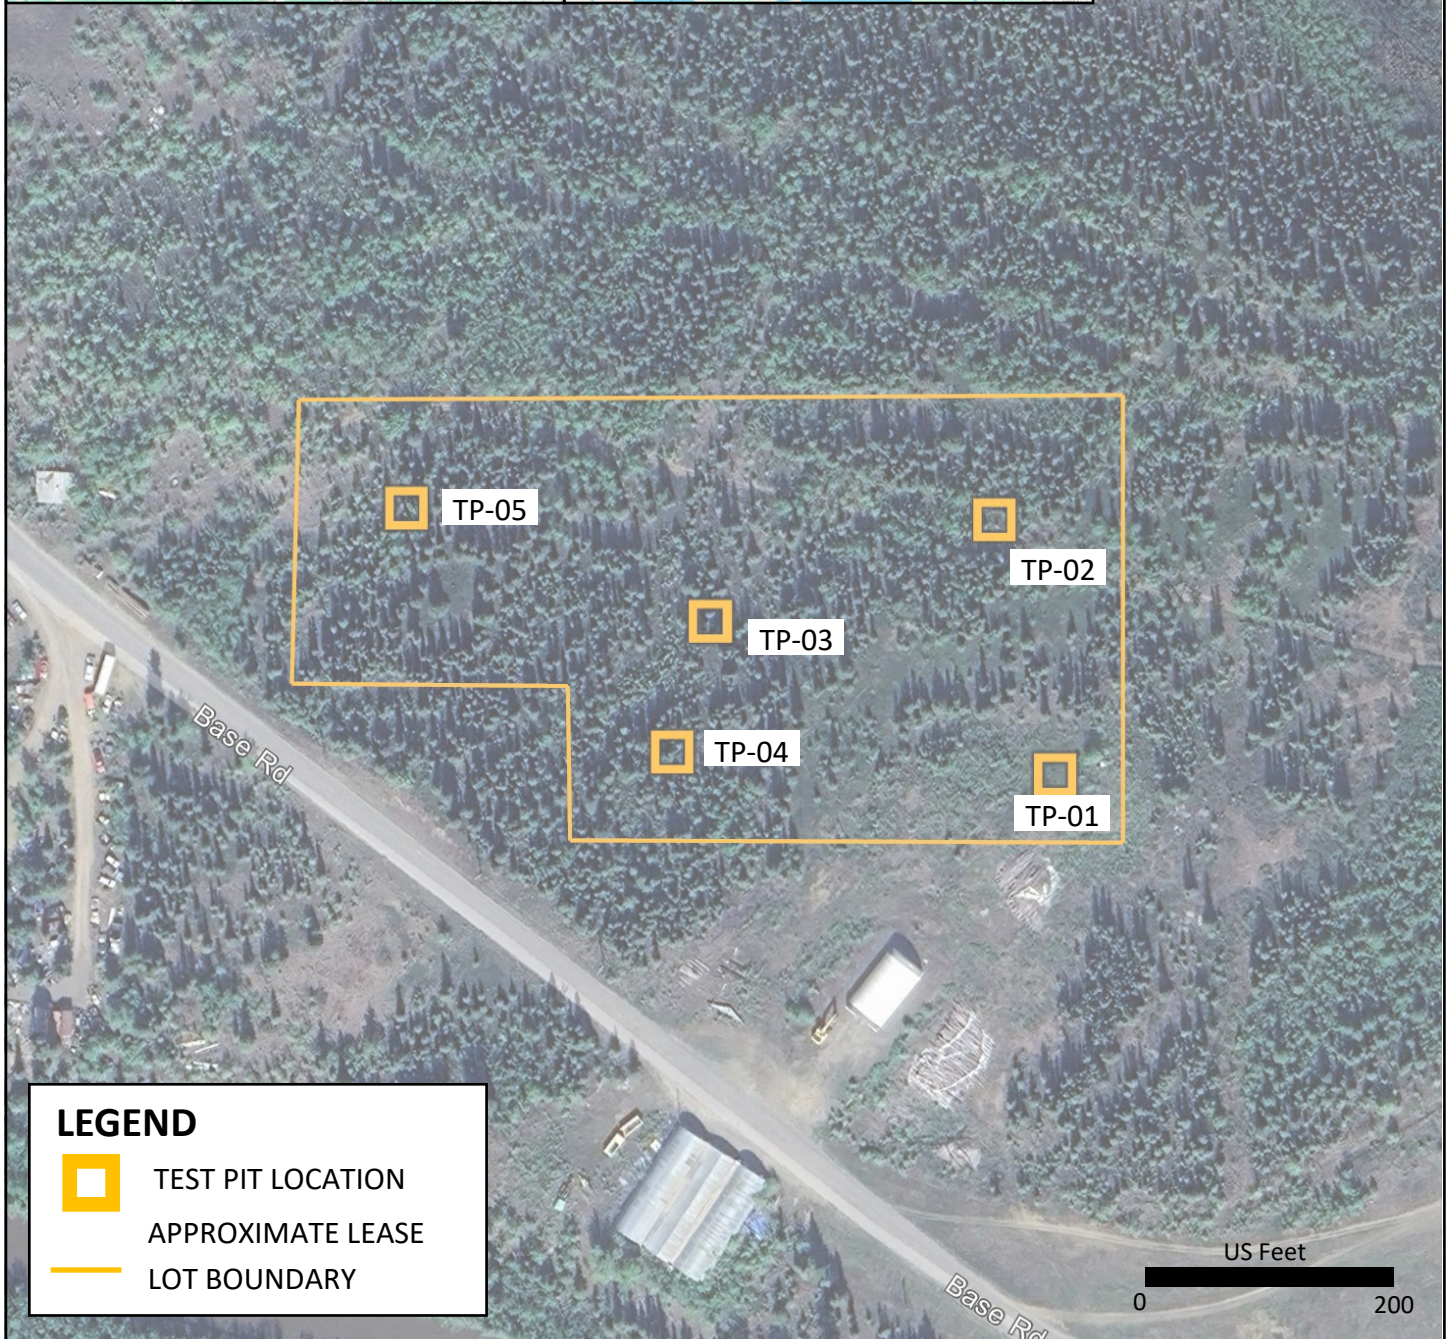
- 1) Vicinity Map and Test Pit Locations

Samples were collected from significantly distinct soil layers observed in the test pits. Samples were either collected from the test pit wall (above 3 feet below ground surface (BGS)) or from the excavator bucket. The recovered samples were visually classified in the field before being individually sealed in plastic bags and transported back to Anchorage for additional laboratory testing. Soil characteristics such as classification, moisture, color, and plasticity were noted for each sample recovered in addition to permafrost bonding, where observed. Classification in the field was completed following the Unified Soil Classification System (USCS) according to ASTM D2487. Test pit logs are in Appendix B.
